C & C TECHNOLOGIES, INC.

A TECHNICAL REPORT

PHASE 2: SEA LION CONFIGURATION

NRL CONTRACT N00014-94-C-6005

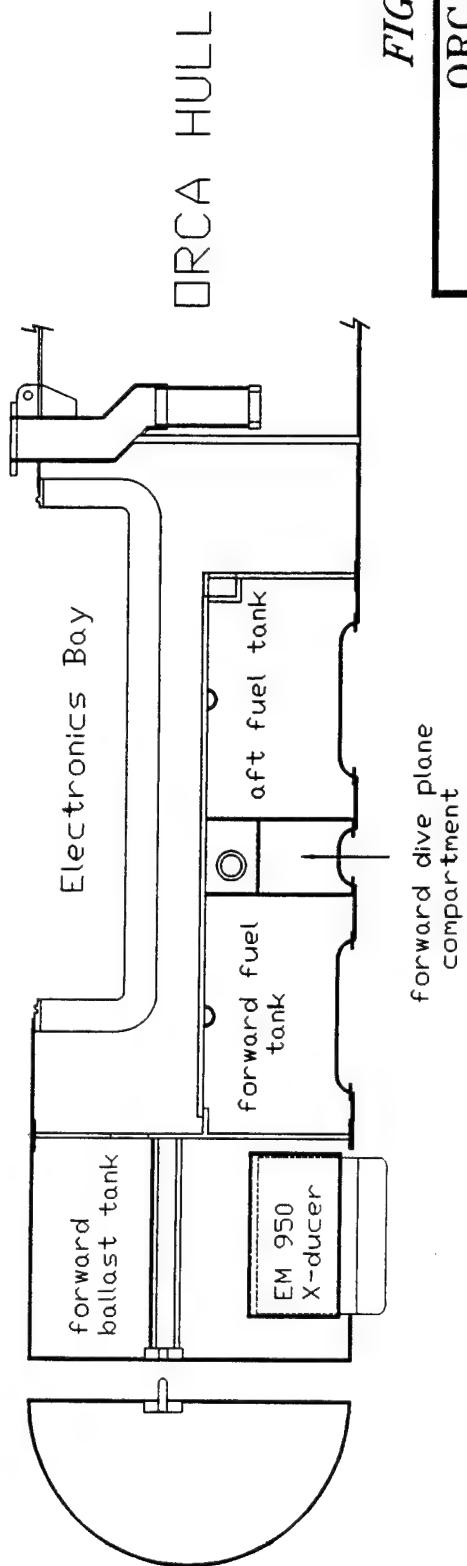
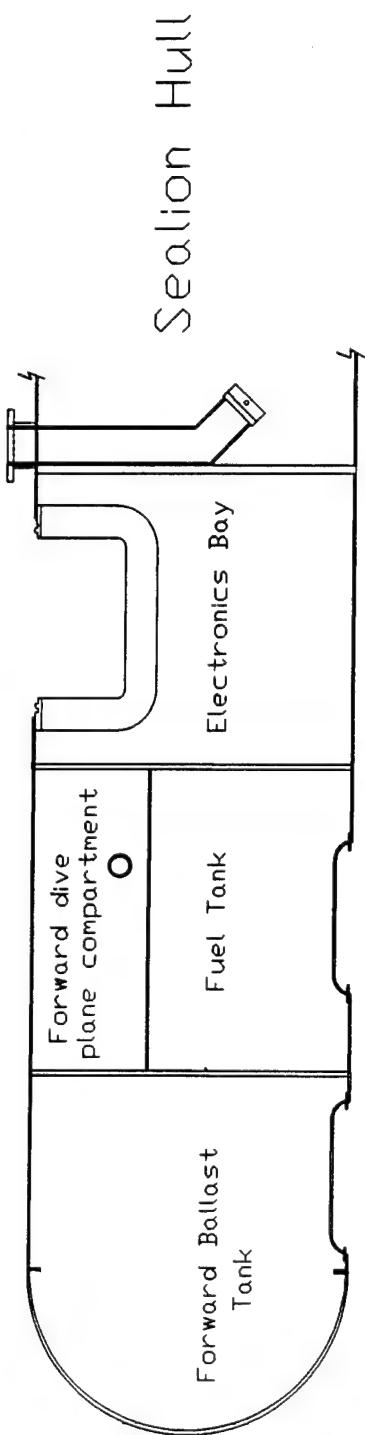
FIGURE 1

C & C Technologies in co-operation with GEO Resources engineered changes to the existing Sea Lion hull which were reviewed and approved by NRL. The Sea Lion's new mission parameters would require the removal, and fabrication of a redesigned forward hull section. The Sea Lions forward hull configuration had two major design deficiencies, a large but limited electronics space, with no heat sinking surfaces, and the forward dive planes and fuel tanks encompassing the entire hull, preventing forward extension of the electronics space. The new design divides the forward hull section horizontally with the upper half dedicated to electronics bay and lower section housing the fuel tanks and dive planes. (See Figure 1)

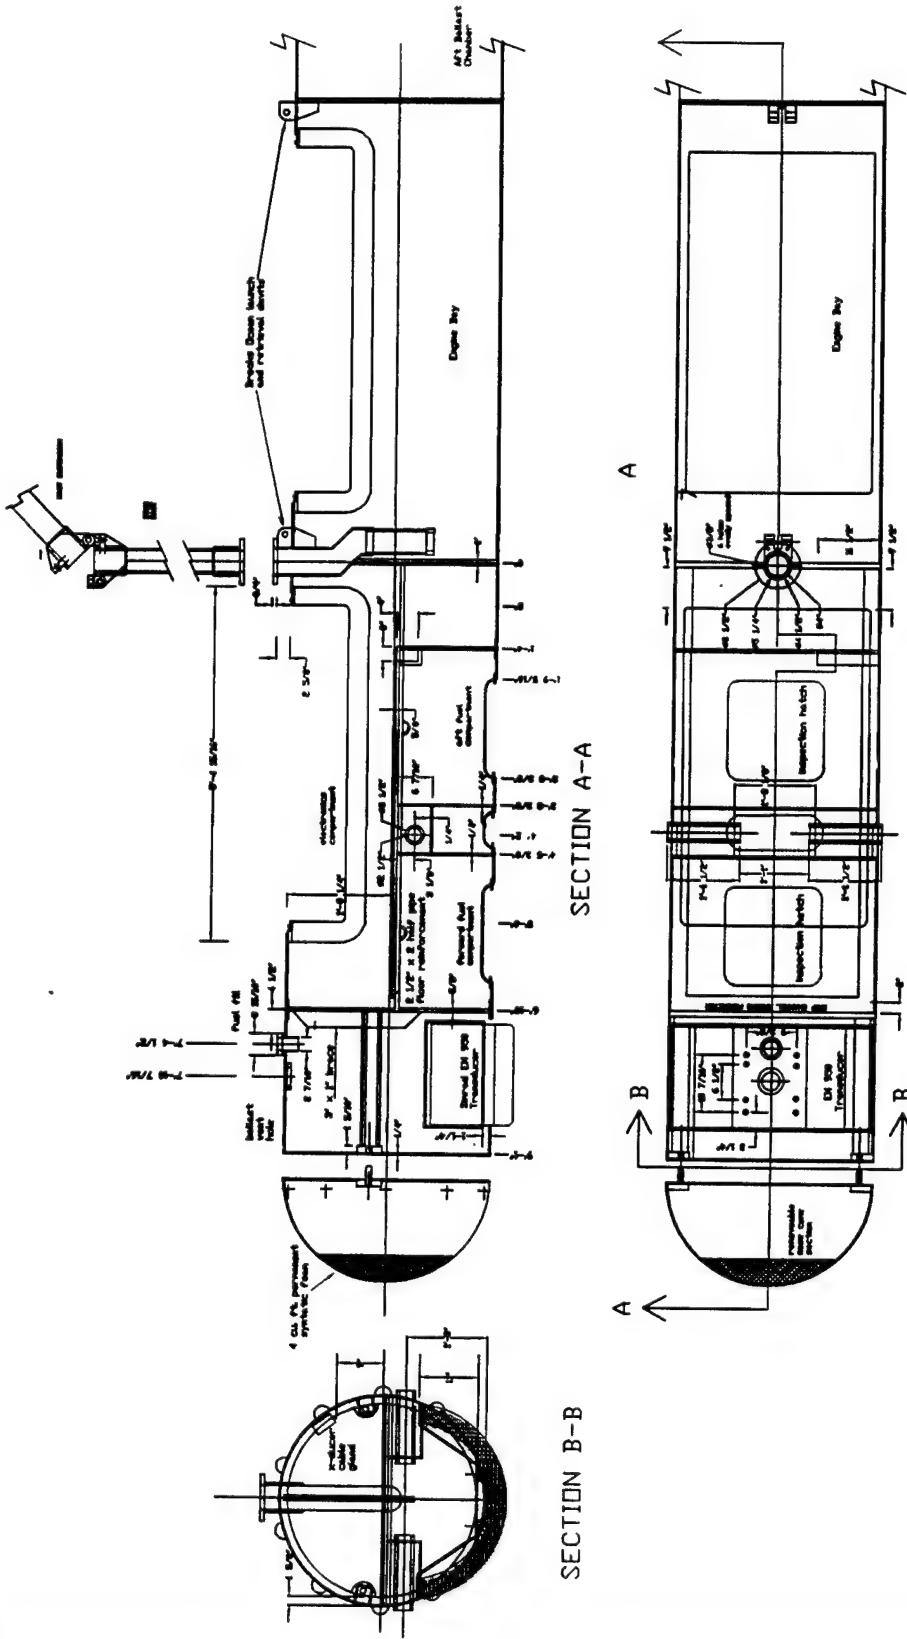
FIGURE 3

Upon design approval the hull was stripped of all electronic and hydraulic systems, engine removed for over haul and all subsystems removed for inspection and testing. The Sea Lion body was transported to Bollinger Ship Yard, Lockport Louisiana, where the hull was cut in half, 10.5" forward of the electronics bay/engine room bulkhead. A reconfigured section was rolled from 3/16" 6061 aluminum plate, cut to a length of 8'-1 1/2", and welded to the aft hull. The new section would house a 36 sq. ft. electronics bay, a net volume gain of 12.3 sq.ft over the old Sea Lion's electronics bay. The new electronics bay has a drop step directly forward of the engine room/electronics bay bulkhead designed to house the existing Robertson SKR-82 Gyro Compass. The computer control box rests just above the gyro (See Figure 2). This location takes advantage of existing cable configurations and minimizes antenna cable lengths. A 5/8" thick aluminum floor plate 63" x 34" extends from this point forward to the ballast chamber bulkhead. This plate separates the fuel tanks from the electronics bay. It also functions as a heat sink for the electronics bay due to its large mass, and the under side is open to sea water through the fuel tanks. In the event of a hatch leak, a 2" wide drip tray surrounds the electronics bay floor

for the water to pool. The drip tray routes water to the electronics bilge area which pumps into the engine room. (See figure 3)

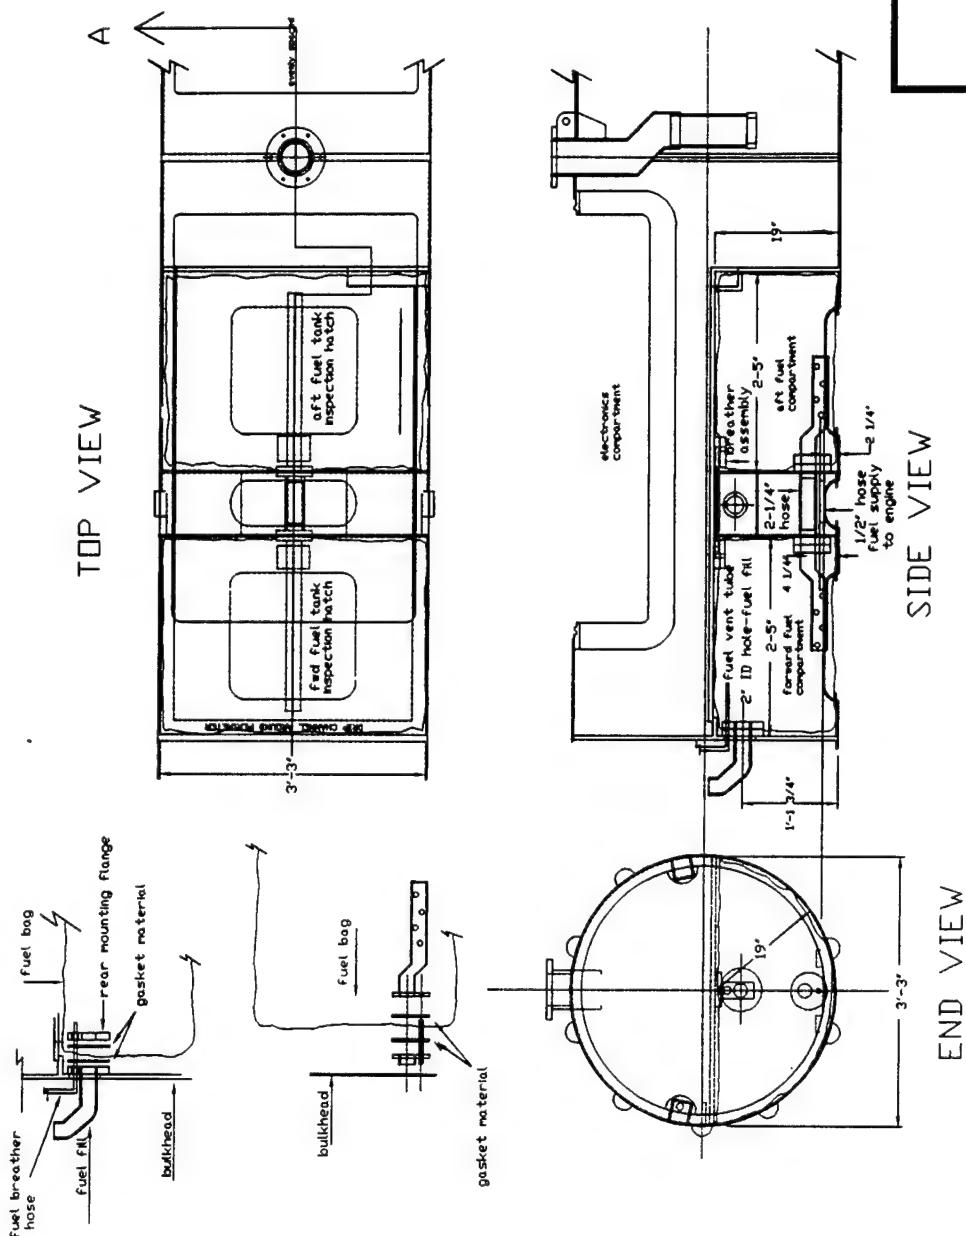
FIGURE 4

The fuel system is divided into two interconnected saddle tanks, bisected by the forward dive planes, each tank has a volume of approximately 8 cu.ft.. This provides a fuel capacity of 116 gallons, an increase of 14 gallons. The fuel is contained in water tight bladders mounted inside the saddle tanks. Each tank is open to sea water through penetrations in the hull, this configuration maintains head pressure on the fuel while the vehicle is submerged. The fuel bladders were manufactured by Western Trading Co. of Slidell, LA. The new bladders were installed in the Sea Lions using the existing hardware. A small fuel leak was detected (seepage). It was determined that the material on the new fuel bags did not allow a proper seal with the existing hardware. New hardware was fabricated with larger flanges, increased bolt hole pattern, embossed flanges, and O-rings. (See Figures 4,5 and 6)

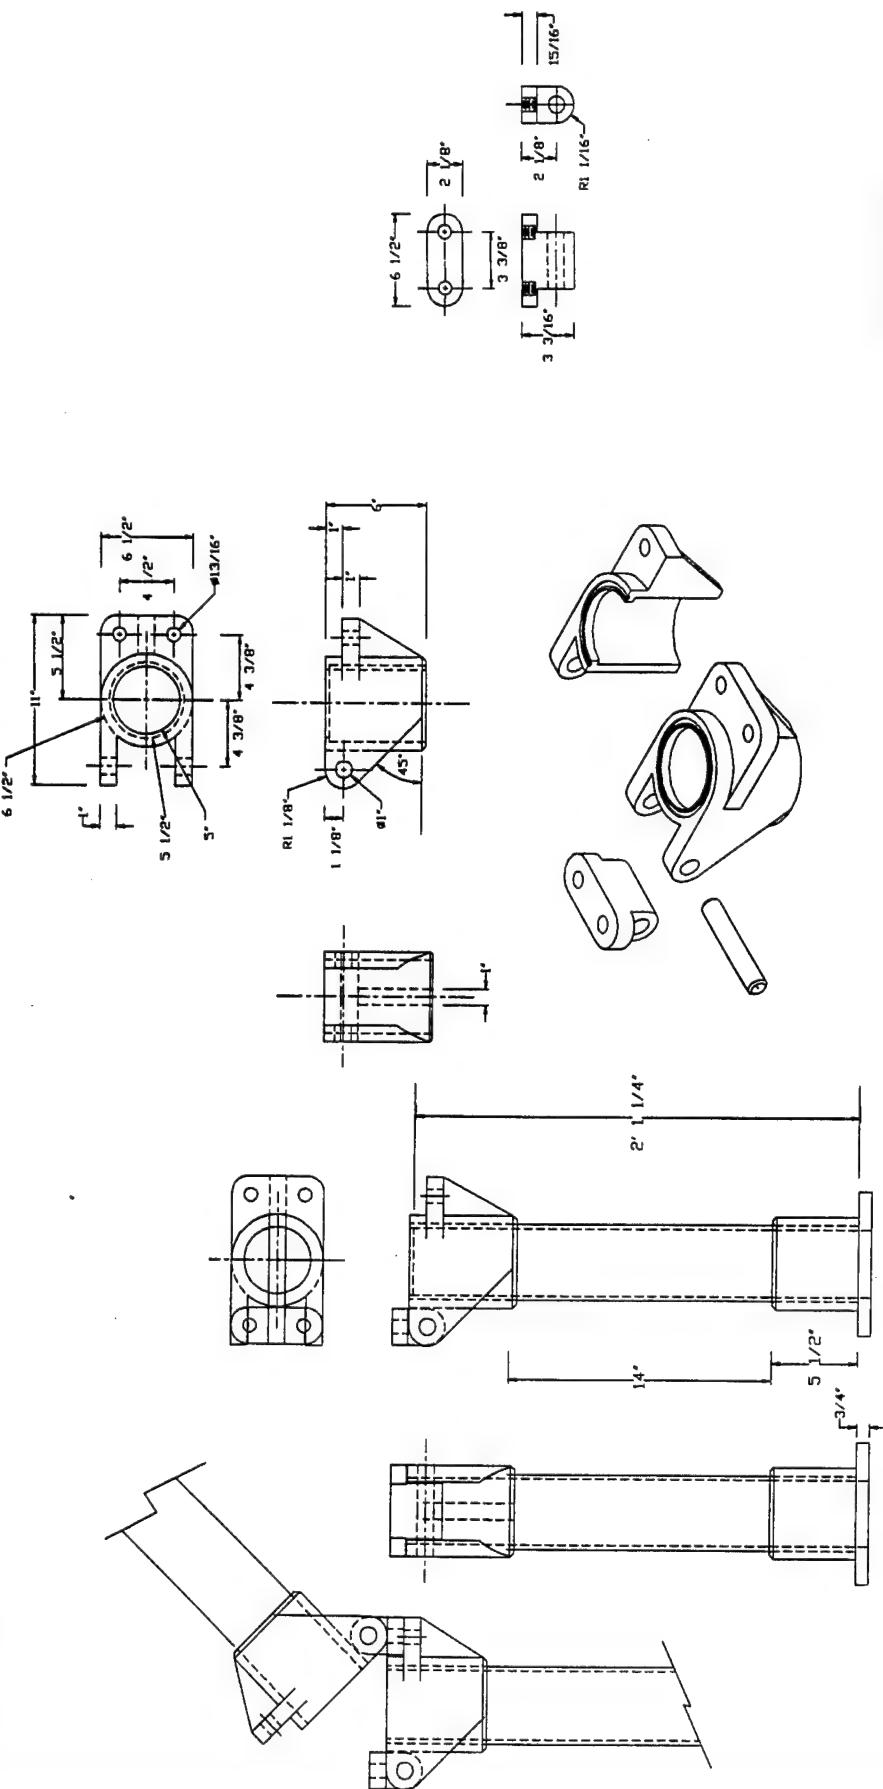
FIGURE 7

A hinged knuckle was incorporated into the snorkel mast 28" from the base of the mast. This knuckle allows the mast to be lowered while remaining secured to the vehicle during transportation. This eliminates the requirement to remove the mast for transportation. (See figure 7)

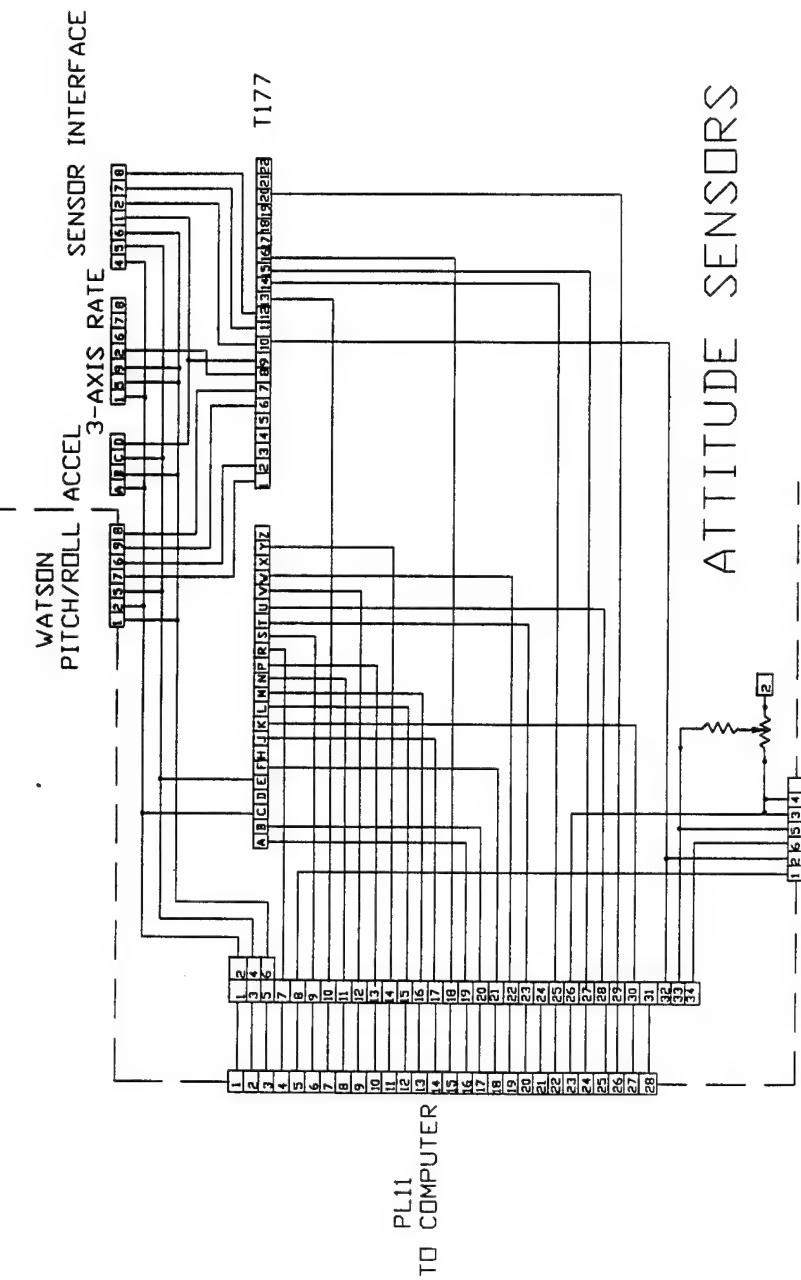
FIGURE 8

Very few changes were necessary during the electrical refurbishment. The attitude sensor was replaced because the mean time between failure was about 500 hours. A Watson Industries, Inc., ADS-C232-1A, Displacement/Rate Sensor replaced the old attitude sensor. The new sensor has a mean time between failure rate in excess of 50,000 hours. (See schematic at figure 8).

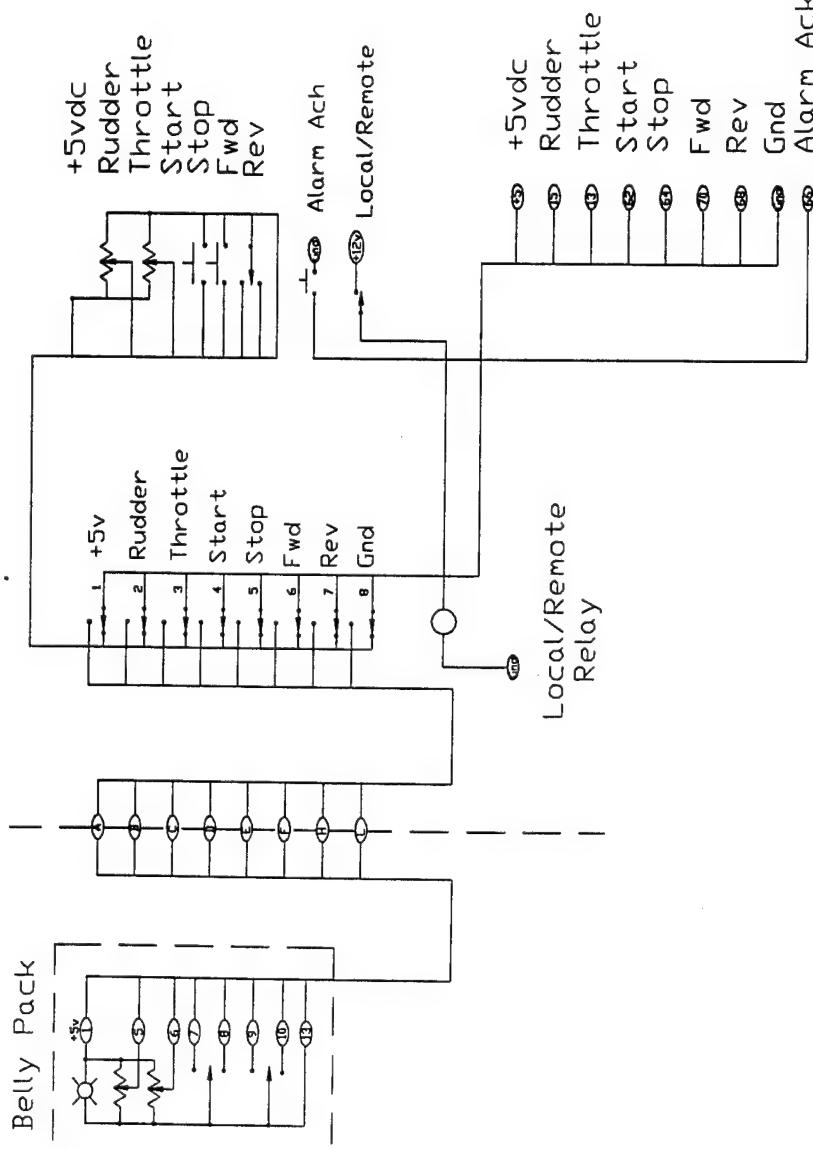
FIGURE 9

C & C Technologies engineered and built a belly pack for the Sea Lion. The belly Pack is necessary for safe maneuvering of the vehicle during launch and recovery operations. (See schematic at figure 9).

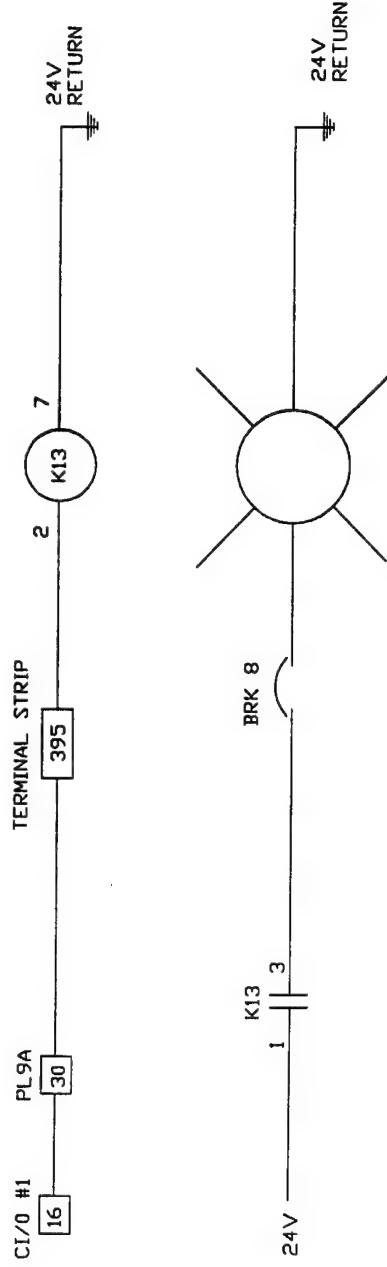
FIGURE 10

A relay was added to the control circuitry to turn the strobe light on and off. Software provisions were available but no control circuitry existed to implement the software commands for strobe on and off. (See schematic at figure 10).
